NRL Memorandum Report 2182

Measurement and Removal of Freon-TF From a Submarine Atmosphere

Report of Trip to USS SALMON, SS-573

November 1970

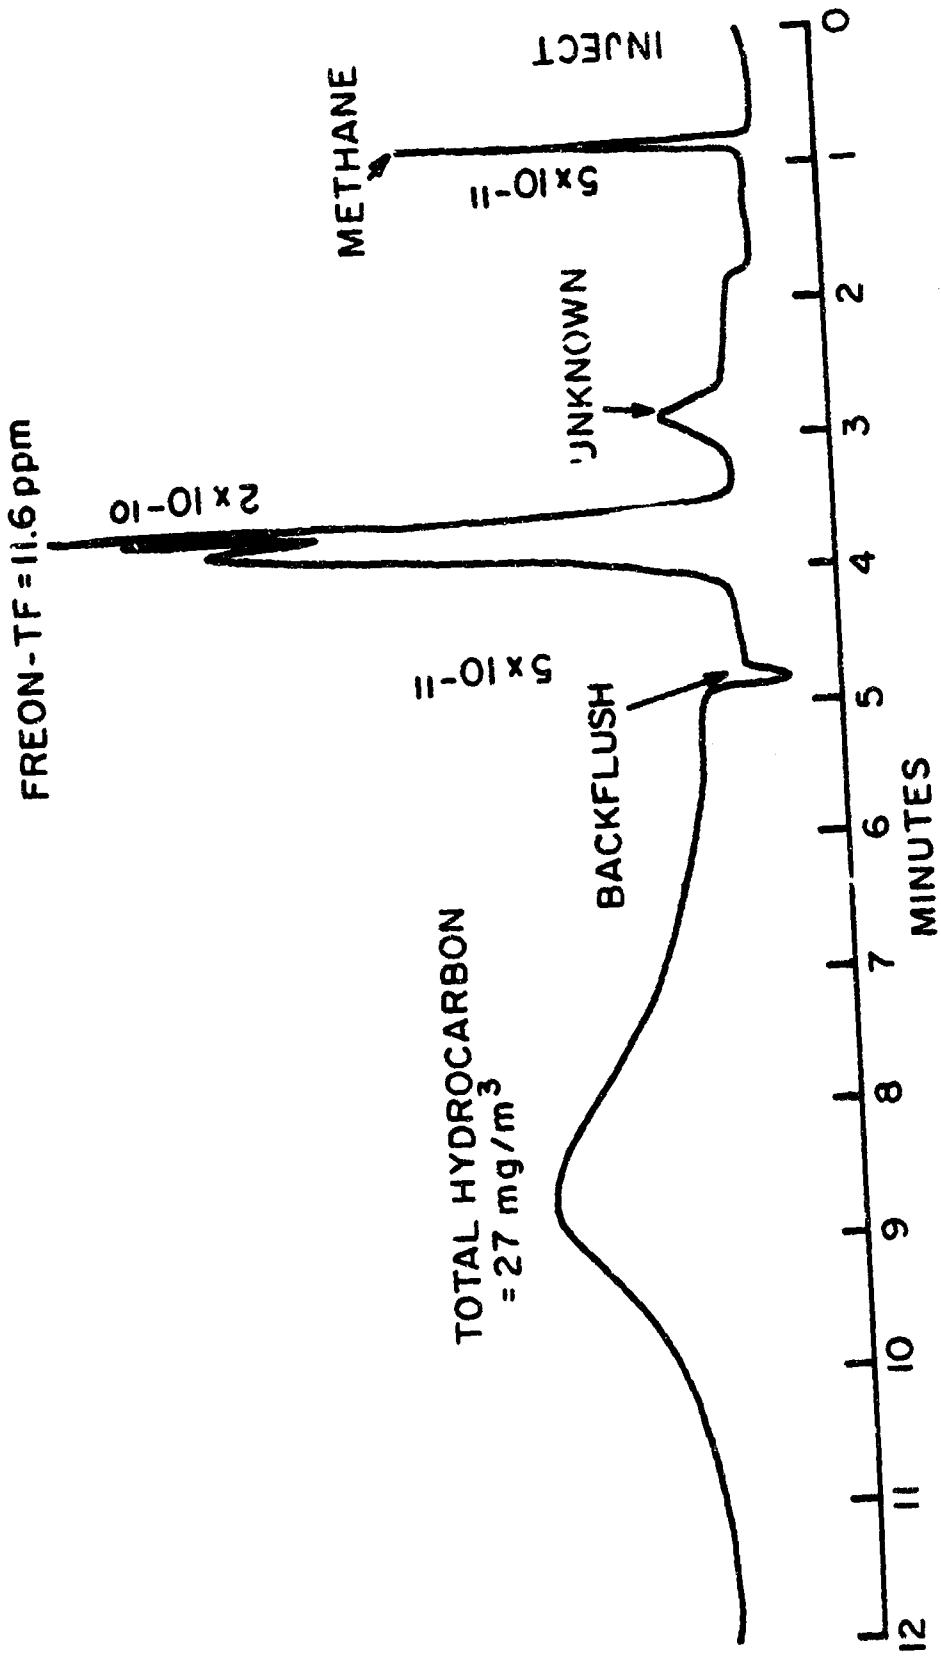
A typical chart record of the analysis of the submarine atmosphere is shown in Figure 1. The THA was operated in a normal gas chromatographic fashion until after the detection and elution of the Freon-TF. The carrier gas passing through the separation column was then reversed to regroup the remaining contaminants into one measurable total hydrocarbon peak. As indicated in Table 1, the background concentration of total hydrocarbons was approximately 30 mg/m^3 . This value increased to a recorded 70 mg/m^3 in the Bilge area during the washing operation on 23 July.

In general, as the concentration of the Freon-TF decreased, the total hydrocarbon concentration also decreased. An exception to this, however, was noted on 26 July at 1345 hours from a sample taken in the Bilge area where a recording of 62 mg/m^3 of hydrocarbon was recorded in contrast to samples taken in the other two areas, Engine and Generator levels, where the recordings were 29 and 37 mg/m^3 , respectively.

Fig. 1 - Typical analysis of submarine atmosphere
